Manhole Inspection Summary

Manhole # S19K1_025MH

Location Address: **2422 puget st**

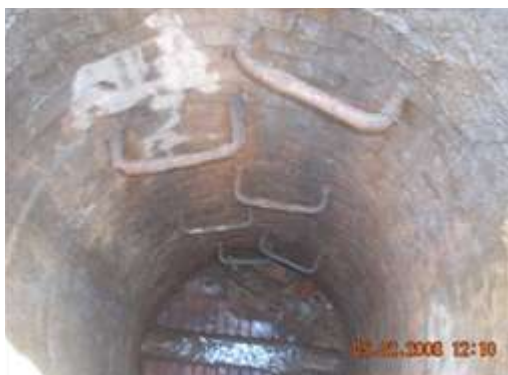
Defect 4

Count: **6** Missing: **0** ☒ **Corroded**

corroded steps, bench debris

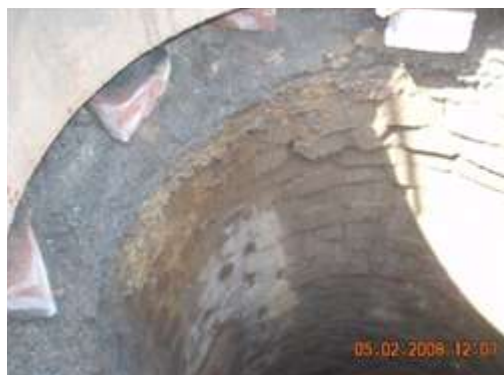
Defect 3

Infiltration: ☐ None ☒ **Joint** ☐ Cracks ☐ Mortar ☐ Roots ☐ Wall

infiltration @ chimney/frame joint

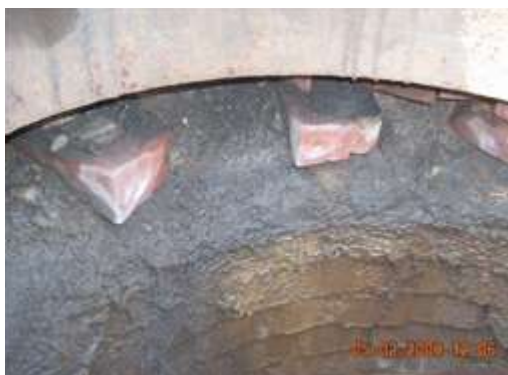
Defect 2

deteriorated chimney

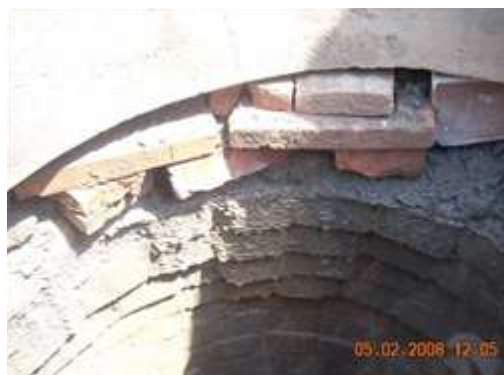
Defect 1

Condition: ☐ Sound ☒ **Cracked** ☐ Root Intrusion ☒ **Loose Brick** ☒ **Deteriorated**

cracked and loose chimney bricks

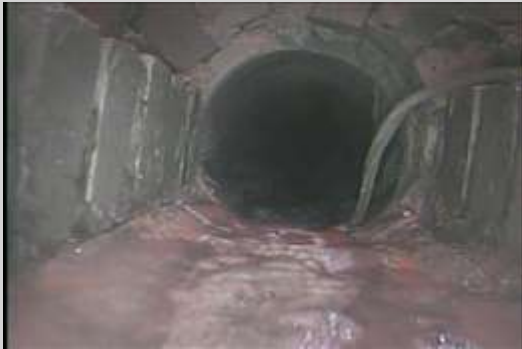
12 O'Clock Outflow

8 in. Circular Gravity Sewer
Pipe Out @ 12 O'Clock

Pipe Height: **8.4** (in.) Rod and Bar (Angled)
Pipe Material: **Clay** ☐ Pipe Lined
Invert Depth: **11.00** (ft.) Flow Characteristics: **Slow**
Deposits: ☒ None ☐ Mud ☐ Sludge ☐ Debris ☐ Grease
Silt Depth: **0** (in.) Deposits Extent:
Infiltration: **None** Pipe Seal Cond: **Sound**

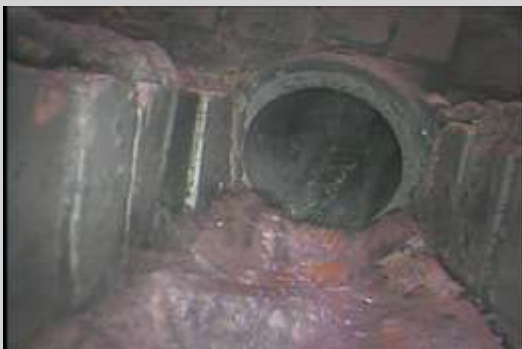
6 O'Clock Inflow

6 in. Circular Gravity Sewer
Pipe In @ 6 O'Clock

Pipe Height: **6** (in.) Rod and Bar (Angled)
Pipe Material: **Clay** ☐ Pipe Lined
Invert Depth: **10.80** (ft.) Flow Characteristics: **Slow**
Deposits: ☒ None ☐ Mud ☐ Sludge ☐ Debris ☐ Grease
Silt Depth: **0** (in.) Deposits Extent:
Infiltration: **None** Pipe Seal Cond: **Sound**
